Assessment of trees at Camp Reserve,  
Castlemaine

## **Arboricultural Impact Assessment**

**Prepared For:** Mount Alexander  
Shire Council  
Corner Lyttleton and  
Lloyd Streets  
Castlemaine VIC  
3450

Cameron Ryder inspected the trees within proximity to the proposed Stage 1 works as requested on Thursday, 22 February 2024. The following data are presented in this report:

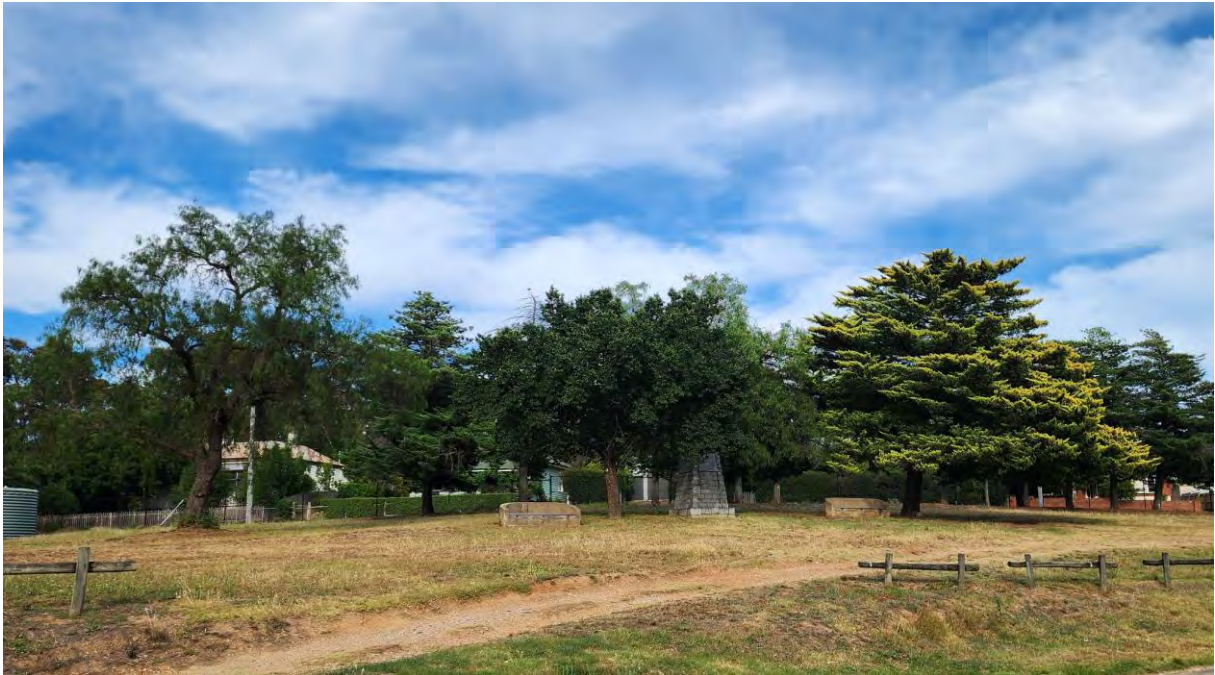
Figure 5: Trees 12-15 around the existing memorial.

Trees 12-15 were located around an existing war memorial and associated seating (Figure 5). They all had fair health and structure with long ULEs. Trees 14 & 15 both had broken branches.

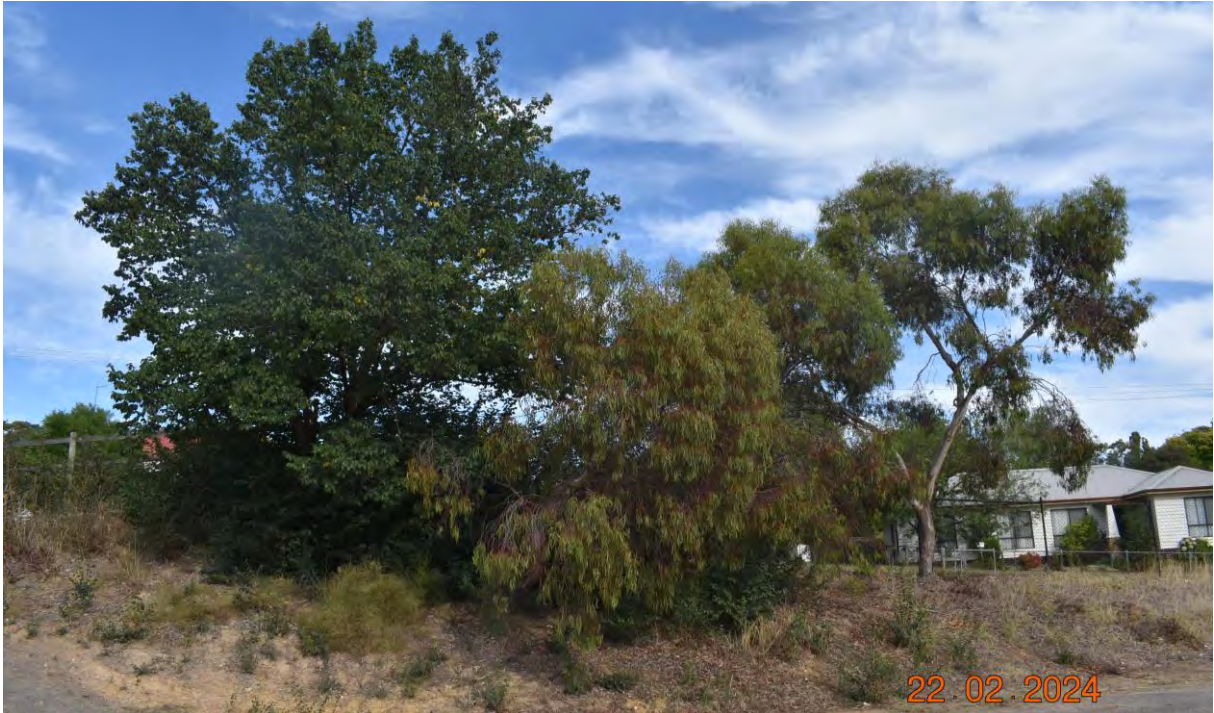
Figure 6: Trees 19-22.

- Trees 16 & 19-21 were a cultivated form of Yellow Gum *Eucalyptus leucoxylon* 'Rosea'. The trees were planted at the site and are likely to be approximately 20-30 years of age (Figure 6). They all had fair to good health and structure with ULEs of 11-20 years. This cultivated form of Yellow Gum often suffers branch failures in maturity.

- Tree 22 was a multistemmed Dutch Elm (Figure 6). It is unclear whether this tree was planted; however, given the multistemmed growth habit, it is possible that what exists today is just stump regrowth from a tree that was removed some time ago. Dutch Elm has a propensity to sucker and so the surrounding shoots are likely to be root suckers.

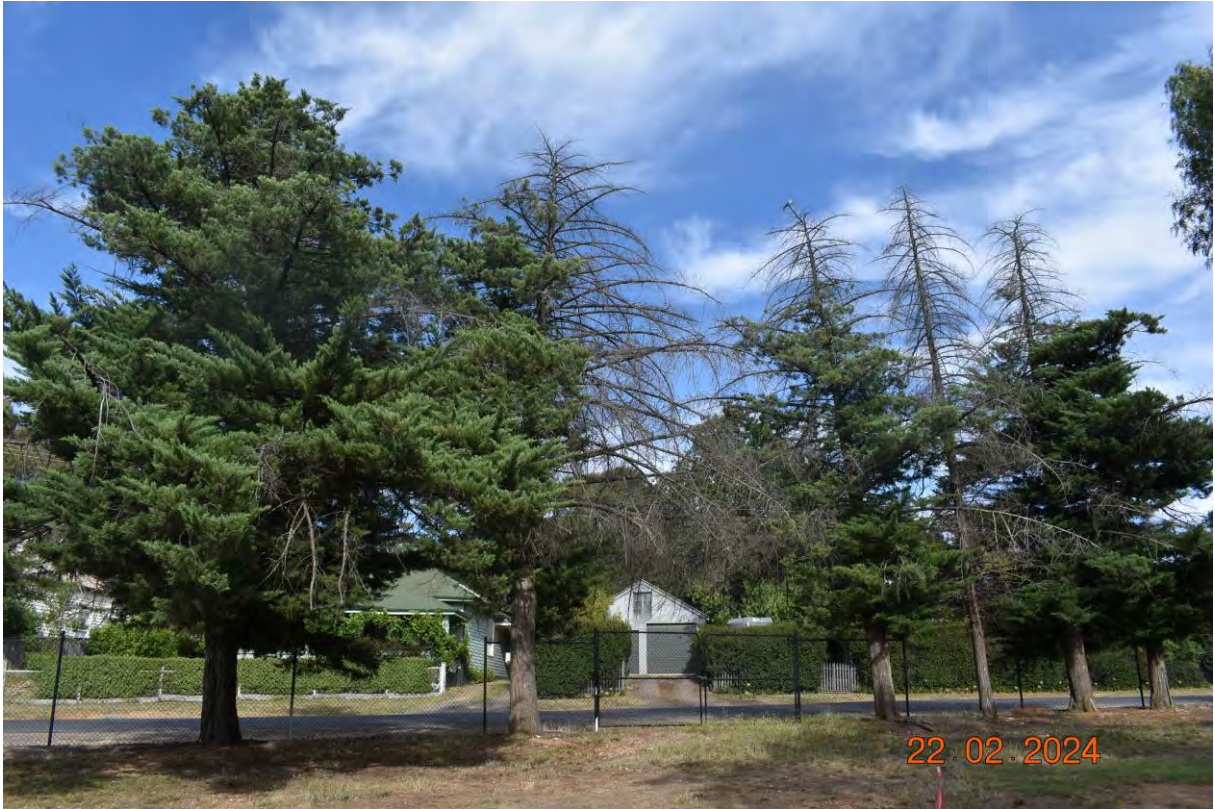
Figure 7: Trees 23-28.

Trees 8-11 & 23-37 were all Monterey Cypress growing along the fence line. Based off the alignment and aerial imagery, it appears that there was an entire row along the fence line; however, several have been removed over the years.

The trees were generally in a state of decline with deadwood and broken branches evident. They were all assessed with fair to poor health and structure with ULEs between 0 and 10 years. It is likely that the trees were suffering from Cypress Decline, a term given to a number of different fungal pathogens including Cypress Canker (*Seiridium* species), *Botryosphaeria*, *Phomopsis* and *Pestalotiopsis* species (DEDJTR 2017). These fungi can all cause dieback, particularly if the trees have been stressed.

The fungus kills the plant's vascular tissue, sometimes causing characteristic sunken, lens-shaped cankers and ringbarking. This interferes with the vascular system of the tree and eventually causes death above the wound. Generally, older trees are more susceptible but any tree is susceptible if in a stressed state (DEDJTR 2017, Sinclair & Lyon 2005).

These trees were in poor condition and should not be considered a constraint to the site.

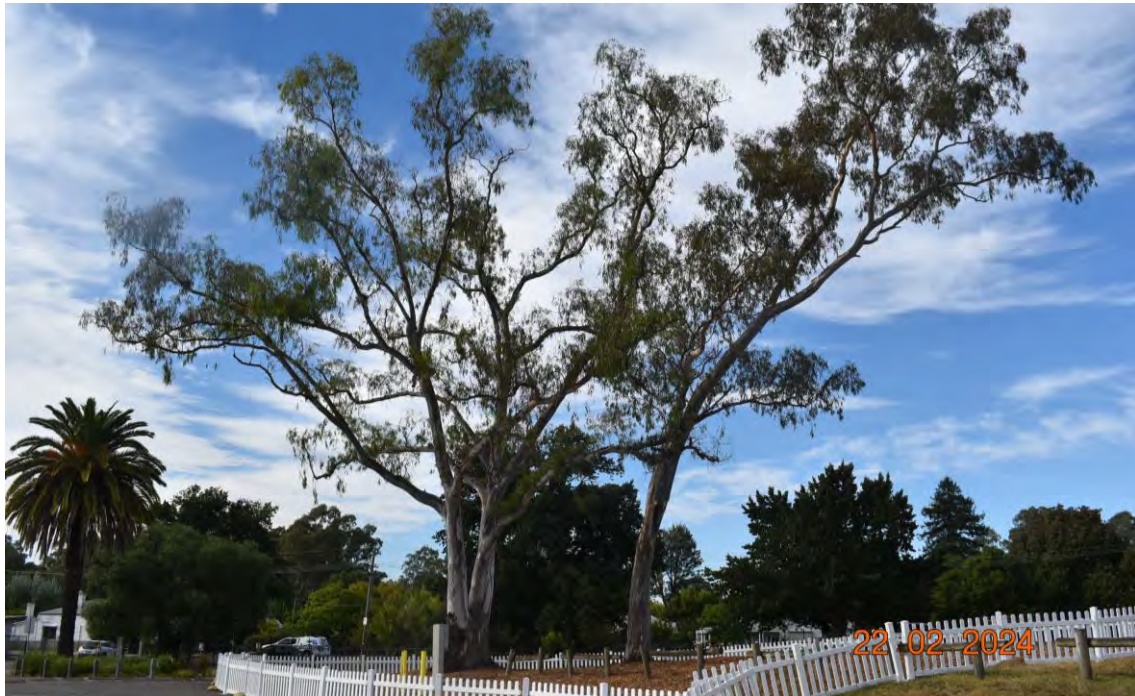
Figure 9: Trees 3 (left) & 4 (right).

Trees 3 & 4 were both large River Red Gum located within close proximity to each other, only a few metres from the asphalt at the southern end of the site (Figure 9). Tree 3 was the larger of the pair, Tree 4 had grown as a somewhat suppressed specimen with a phototropic lean.

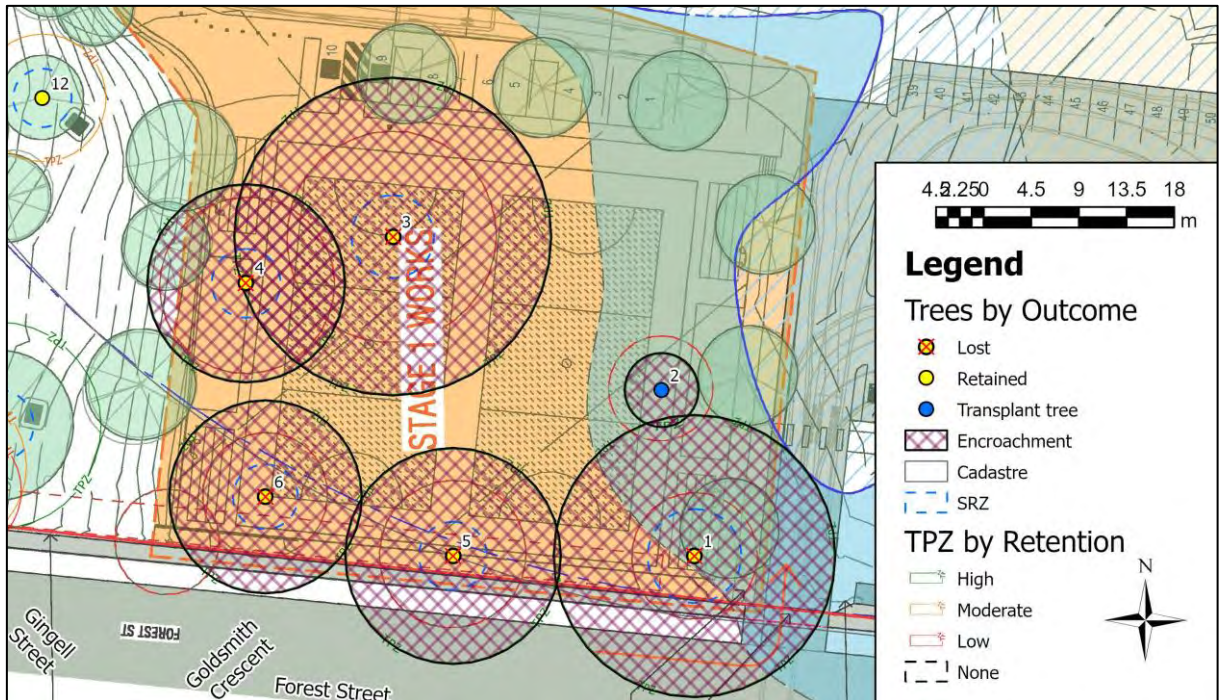
Figure 12: Tree impacts from proposed netball courts.

The proposed netball courts will result in the loss of Trees 1-6, all of which were assessed as high retention value (Figure 12). Tree 2 is a Canary Island Date Palm, and it is proposed to be transplanted into another area of the site. A significant redesign would be required if any of these trees required retention.

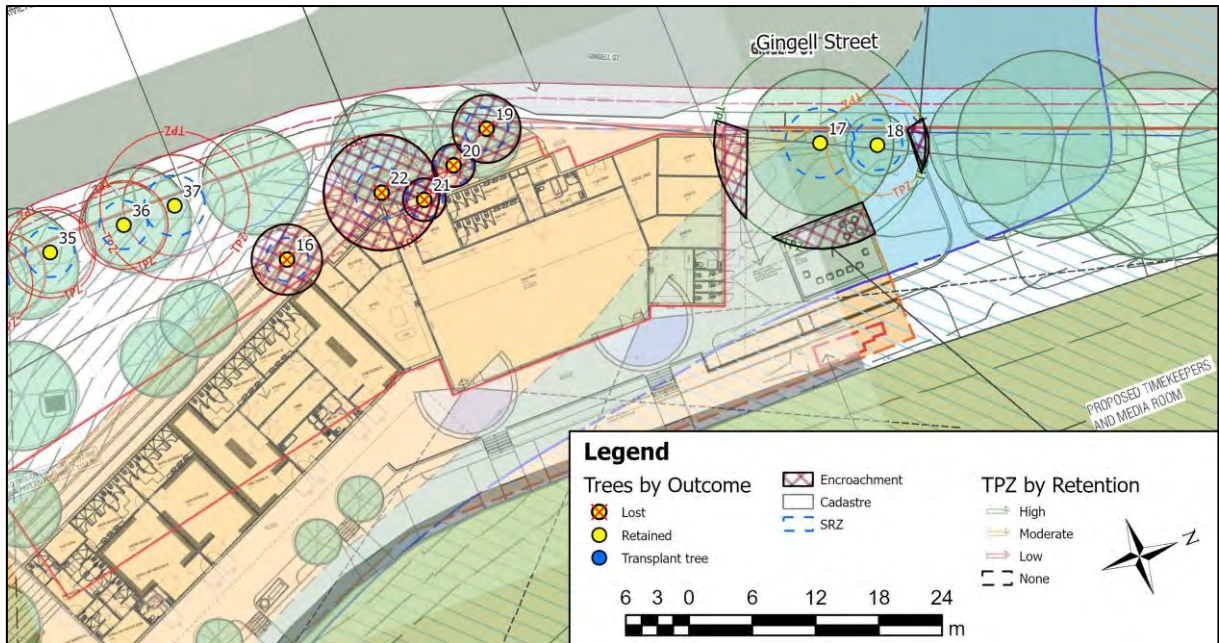
Figure 13: Tree impacts from the club rooms and surrounds.

There will be a 7% TPZ encroachment to Tree 18. This is considered minor encroachment, is beyond the SRZ and the tree will remain viable.
